IDENTIFICATION AND EVALUATION OF FRACTURES USING ELECTRICAL RESISTIVITY TOMOGRAPHY IN THE VICINITY OF THE AXIS OF THE HUAMANTANGA DAM – LIMA – PERU

ABSTRACT. Huamantanga District is located in the central highlands of Peru, in altitudes of circa 3,390 m, where an ancestral Inca water management technique that promotes the “farming” and “harvesting” of water, named “mamanteo”, is used to direct water through a ravine during the rainy season, towards places with high infiltration rates. In addition, the Huamantanga Dam was built to storage water due to the increased agricultural activities. Nevertheless, undesired leaks were observed raising the needs for an electrical resistivity tomography survey to identify the possible leakage zones. Four electric profiles parallel to the axis of the dam were surveyed, two profiles were located upstream from the axis, spaced 10 to 15 meters, and two profiles were situated downstream, being the fourth profile approximately 10 meters above the spring. The resistivity measurements were performed for each of the four electric tomography lines, in order to obtain detailed information of the stratigraphy and to identify low resistive anomalies related

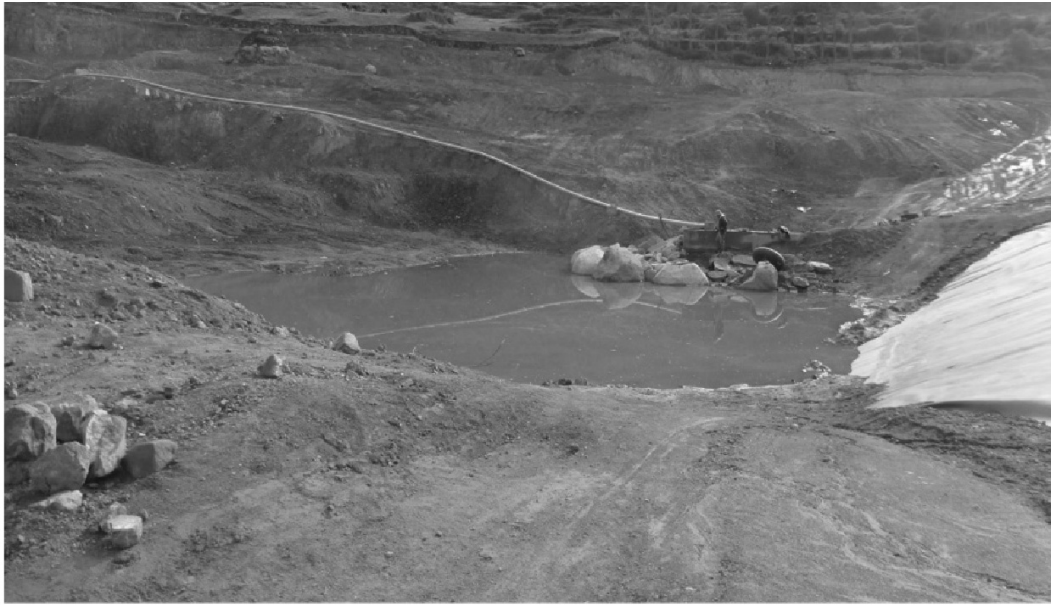
Figure 1 – Photograph of the filtered water pond.

After field recognition, we decided to conduct electrical resistivity measurements using electrical tomography, at the edge of the geo-membrane (Fig. 1). In order to provide strong contrasts of resistivity, we dissolved 200 kilos of salt in the pool of water. The first campaign of resistivity measurements was done with natural water conditions on the first day. After dissolving the salt in the water reservoir, subsequent resistivity measurements began, tracing the salt water route. The results of the two campaigns were integrated, according to the following steps:

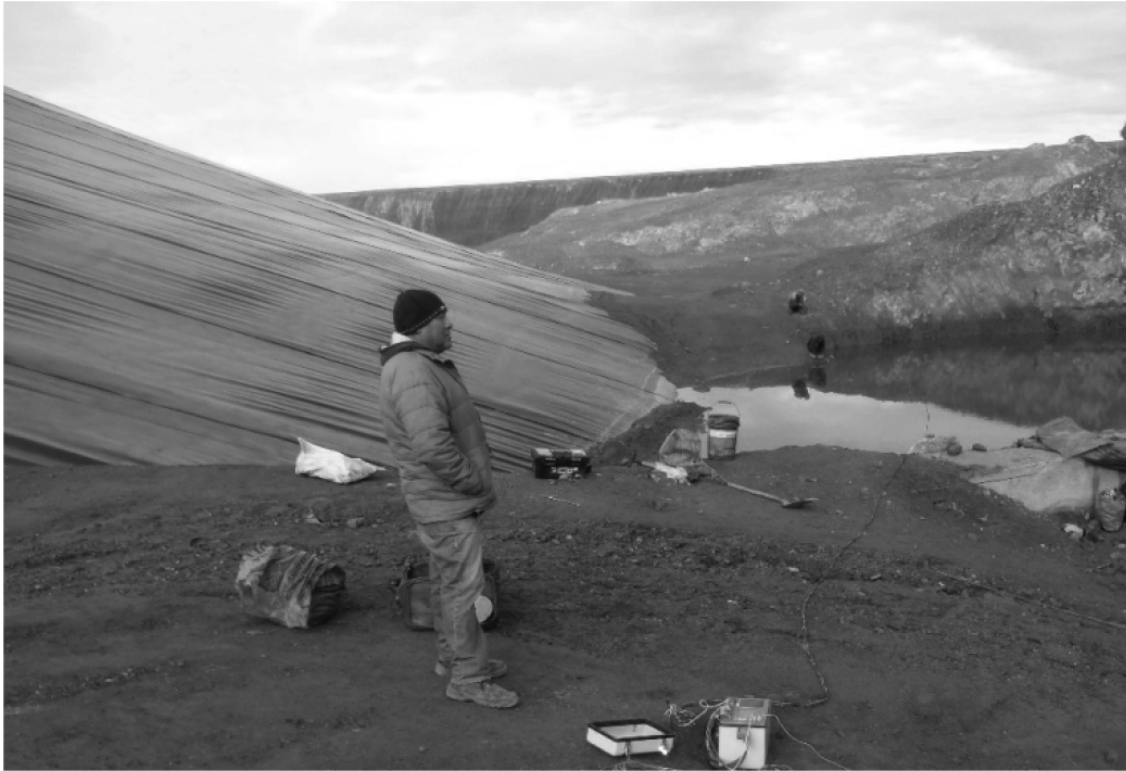
Section ERT-04B has a length of 100 meters in a E-W direction (Fig. 8). This profile is very close to the spring originated by the waters that infiltrate the dam. This section was surveyed only after

Figure 16 – Tomographic Profile ERT-04 B.

Figure 17 – Limit above the geomembrane and the pool of filtered water.

salting the water. The tomographic profile shows a low resistivity, saturated layer along most of the section, cropping out between distances from 84 to 94 m, which would be related to the water leak that needs impermeabilization. This feature is 3 m wide and the central water spring is nearly 1 m wide (Figs. 16 and 17).
