Multibeam Echosounders Capability to Detect Fluid-Mud layers in the Water column

Aluizio Maciel de Oliveira Junior (DHN and UFF) and Ana Angélica Ligiéro Albertoni (DHN)

This paper was prepared for presentation during the 12th International Congress of the Brazilian Geophysical Society held in Rio de Janeiro, Brazil, August 15-18, 2011.

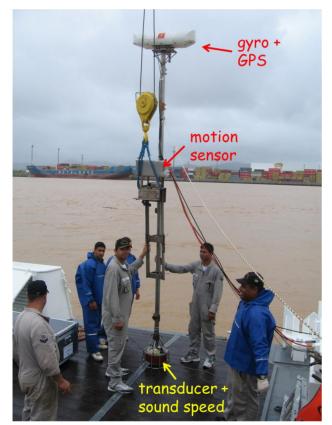
The pole structure used is very stable and easy to mount. DHN developed and sequentially improved this pole structure after several sea trials, where data quality has been evaluated. Experience demonstrated that light poles are more prone to the water turbulence effects. generating noisy data. On the other hand, more robust pole structures would benefit data quality. As showed in Figure 1, all the multibeam sensors are mounted together in the same pole, allowing easier alignment procedures in the harbor location. Then, pole is transported later to the boat. All these steps: pole mounting, sensor alignments and onboard installation took approximately 2 hours. The main pole used in this survey had approximately 5 meters high, in order to clear the transducer from the boat hull and also the gyro and GPS antennas from the boat superstructure. So, transducers can suffer less water turbulence and gyro and GPS antennas suffer less satellite obstructions. The frame holding the pole is also very important, helping to minimize its vibration. When performing surveys in smaller boats, this pole can be mounted using fewer sections, allowing its size reduction. Each pole section has approximately 1 meter and can be screwed inside the others.

Fig. 1 – EM3000 multibeam sensors – pole mounted, ready to be installed in the survey boat (LB Betelgeuse).

This survey required an expeditionary survey in order to quickly provide information about the hazards and depth map in the harbor area. For that, the solution using a portable multibeam installation mounted in a pole has been very appropriate.
